LITTLE PINE CREEK DAM

INVENTORY NUMBER NDS PA-351

PHASE I INSPECTION REPORT

by
BERGER ASSOCIATES, INC.
CONSULTING ENGINEERS
HARRISBURG, PA.

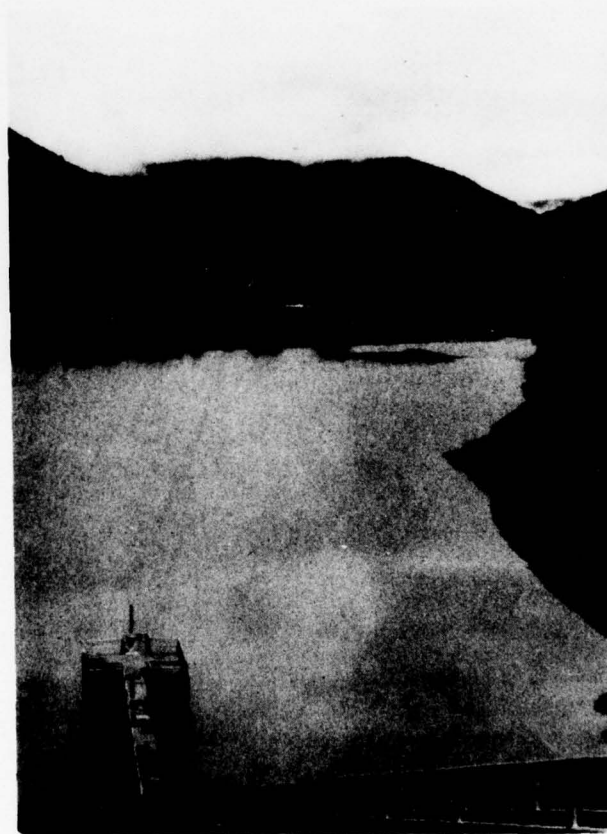
Reservoir & Stairs to Intake Structure

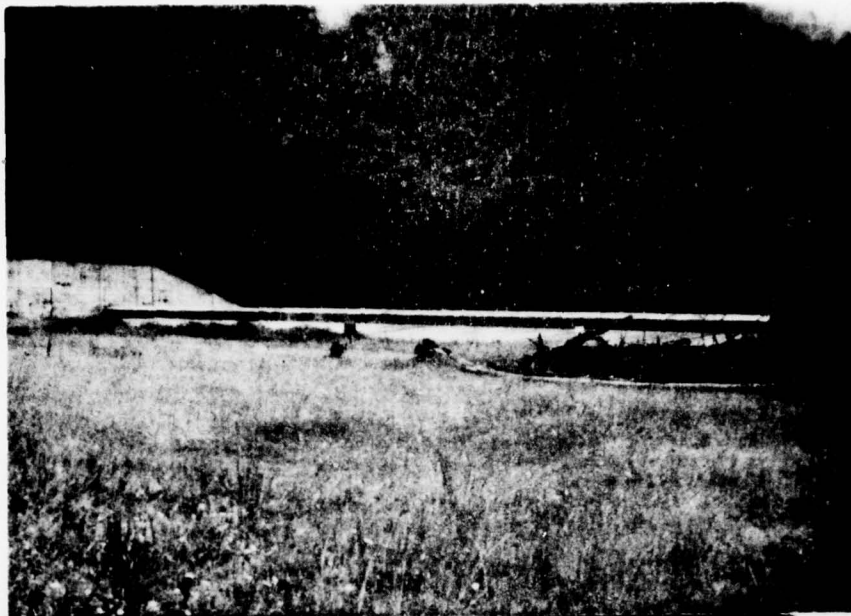
A large forebay area was excavated and is seeded with grass. Some driftwood was piled up in the area, but will be removed. The right side has a curved concrete training wall, the left wall is straight. Some cracking was noticed in the walls, but none of the cracking appeared to affect the structural stability of the walls. Some differential movement at the top of the walls was noticed adjacent to the ogee section. This was caused by variation in support. All the monolithic ogee sections have a vertical crack in the center of the

Forebay

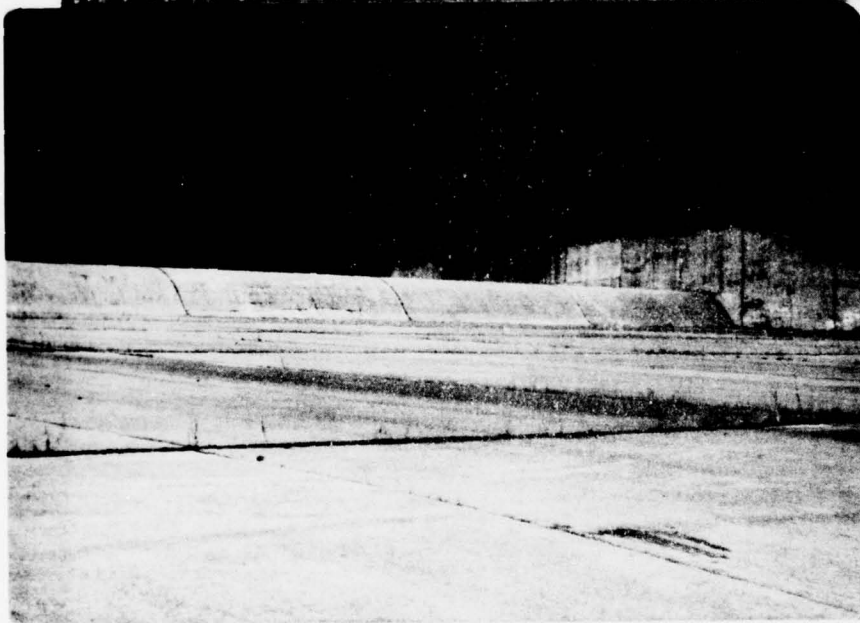
pours, which were approximately 50 feet long. The center section had some horizontal cracking. None of the cracks appear to affect the structural integrity of the structure at the present time. Downstream damage occurred during the tropical storm Agnes (June 1972). The damage has been repaired and riprap has been placed at several locations (Appendix D, Plate VI). A bridge located downstream (Plate VII, Appendix D), was destroyed during that storm and has been replaced several hundred feet further downstream.

A review of the design drawings indicate that all structures were designed and detailed according to acceptable engineering standards. The gravity type walls have a base width of at least half the height and have a drainage system behind the walls. The spillway slab has cutoff walls and a drainage system. Due to the length of pours of the ogee section, cracking has occurred.

Spillway

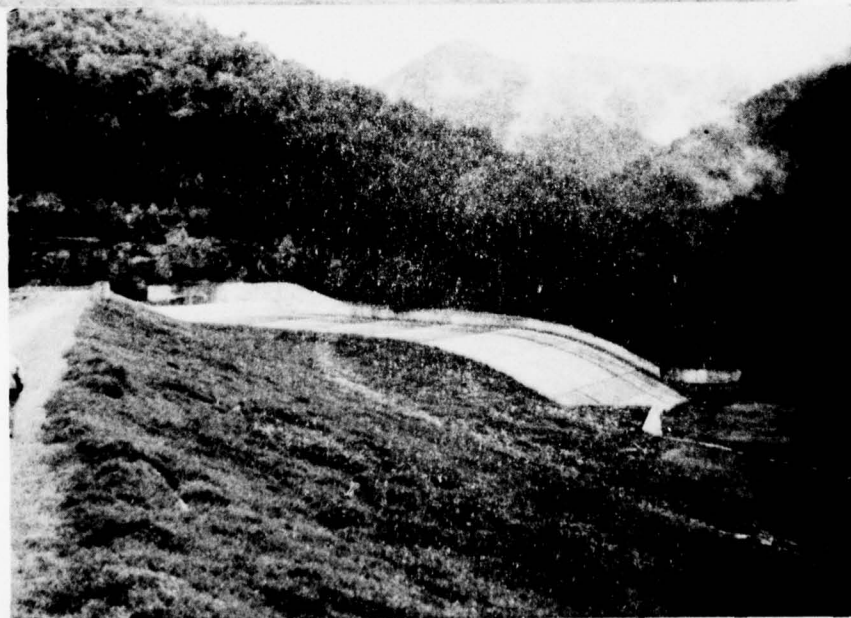
Downstream Slope
& Spillway

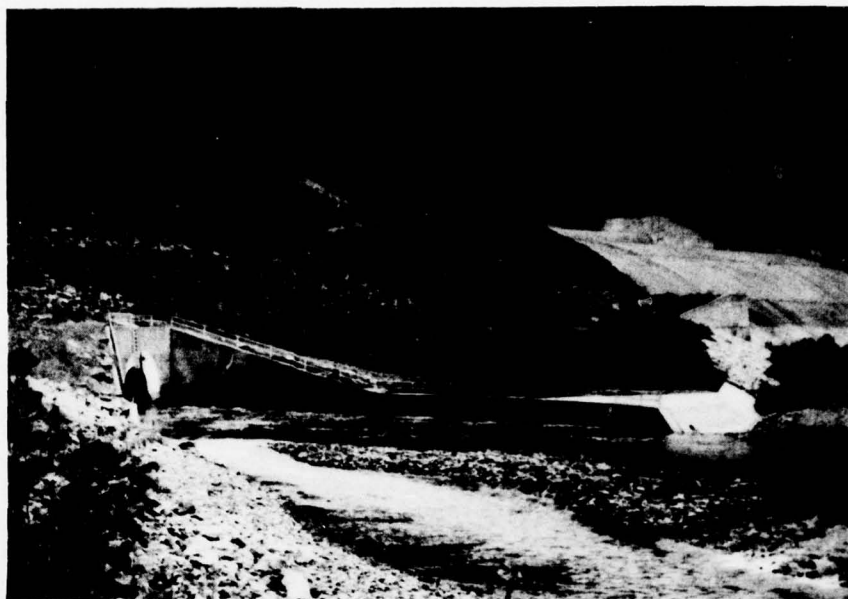
Seepage at left side of outlet below toe of embankment.
Steady flow - clear - park superintendent indicated no change in flow
over long period of time.
This condition on record - appears to come from toe drain or springs.
Estimated 40 gpm± not measured.

Conduit Outlet and Spillway

2. The quantity and turbidity of the seepage exiting at the toe of the dam should be monitored and recorded. Changes in conditions under higher pool level should be noted, to determine if an in-depth study of the seepage condition is required.

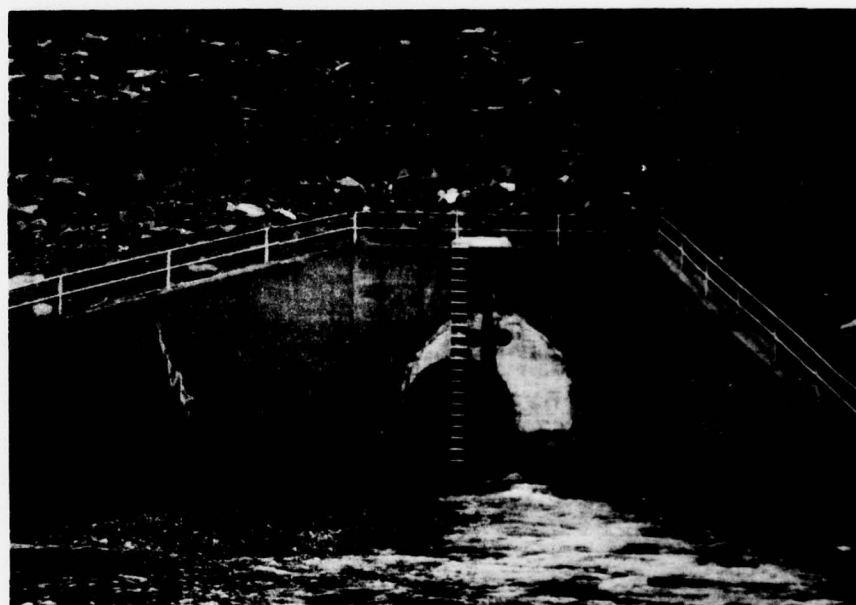
The original construction included a 15 feet diameter concrete conduit which was first used during construction for diversion of stream and is connected directly to the intake structure for pool control after construction was completed. Cavitation during flood flows in 1950 and 1951 caused extensive damage. A new 8.5 foot diameter steel pipe, supported within the original conduit was installed. This steel pipe was damaged during the Agnes storm, but has since been repaired and performs in a satisfactory manner. The damage consisted of slight buckling of the steel plate near the orifice. Improved pipe supports were installed. The discharge through the 5 foot by 5 foot sluice gate runs between the concrete and steel conduit. The steel pipe was inspected and appeared in good condition. A small hole in the top of the pipe was discovered approximately 150 feet upstream from the end of the pipe. The outlet channel was in good condition.

Outlet Steelpipe in Conduit

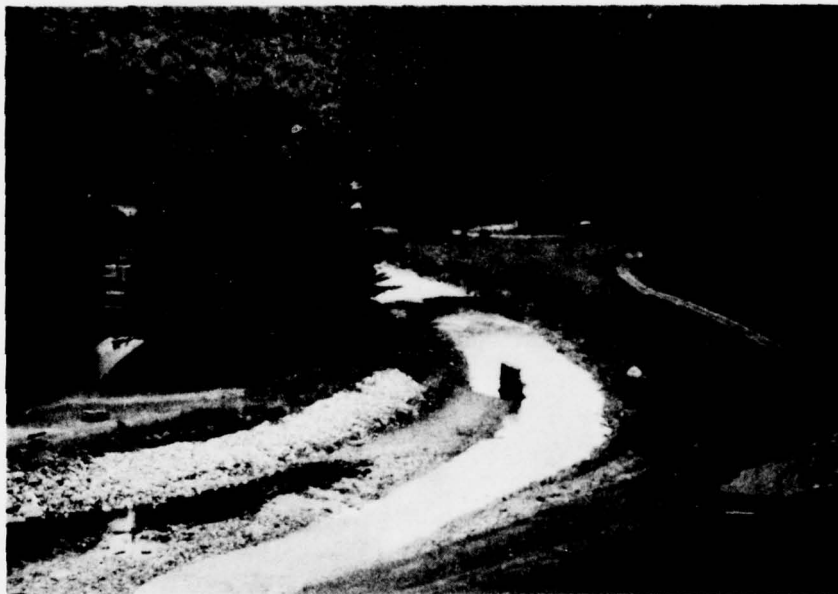
The downstream channel is a natural stream in a relatively narrow valley. Most of the banks adjacent to the stream are wooded, but there are also open meadows. Little Pine Creek joins Pine Creek about 3.8 miles downstream at Waterville, Pennsylvania. It is estimated that there are about 80 permanent homes located between the dam and the mouth of Little Pine Creek, including houses in Waterville. The hazard category for this dam is considered to be "High", due to the expected additional loss of life if dam failure would occur after overtopping.

Downstream Channel
